## Subject: Window Heat Control Indications

A new Window Heat Control Unit (WHCU) is being installed on 737-900ER aircraft 3856 and subsequent. This new WHCU goes through an initialization process when the WINDOW HEAT switches are selected ON and produces indications that could be misinterpreted as abnormal.

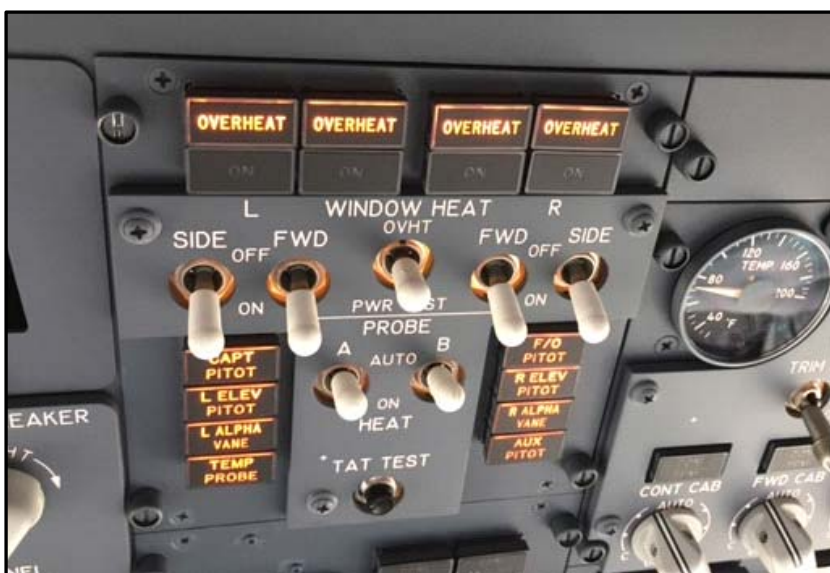
Selection of the WINDOW HEAT switches to the ON position places the new WHCU into an initialization process. The amber window OVERHEAT light illuminates, along with the two master caution lights, and the amber ANTI-ICE light on the system annunciator panel, because during the initialization process electrical power is not being applied to the windows.

After the initialization process completes (in approximately 3 seconds), the amber OVERHEAT lights extinguish. The two master caution lights and the amber ANTI-ICE light on the system annunciator panel can also extinguish. The green window heat ON lights also illuminate.

If the window OVERHEAT lights, the two master caution lights, and the amber ANTI-ICE light on the system annunciator panel extinguish within 5 seconds of turning the window heat ON, the WHCU is operating normally.

If the window OVERHEAT light illuminates during a power transfer, the flight crew should accomplish the QRH WINDOW OVERHEAT procedure in an attempt to reset the system.
