## Subject: Updated FMS U12.0 Operational Software Retrofit

Beginning in mid June, TechOps will commence retrofit of FMS U12.0 on all 737-700, -800, and -900ER aircraft (3801-3852).

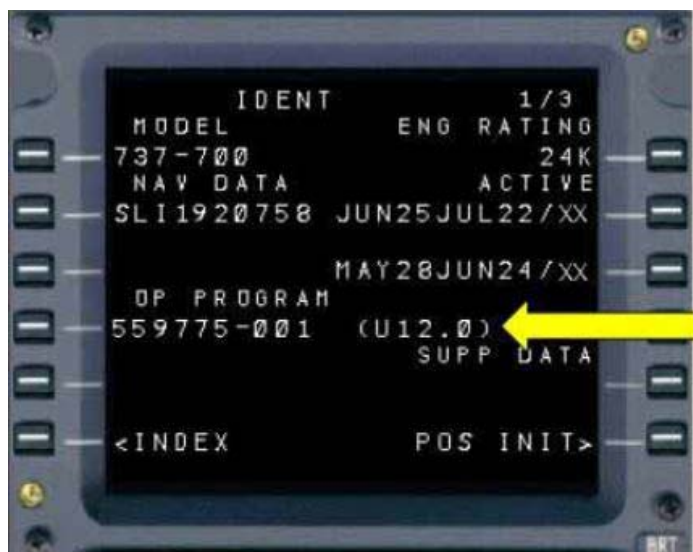
Flight crews should check the IDENT page (LSK 4R) during preflight to determine if FMS U12.0 is installed.

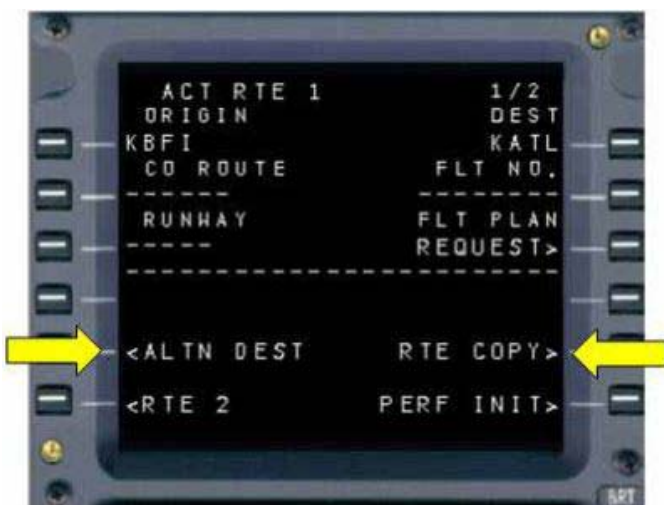
As a result, it is possible to see lingering route data (i.e., ETP or critical terrain boxes) in Route 2. To correct this situation during preflight, the pilot flying should “swap” the databases (DBs).

**Note:** Swapping the DBs to clear the routes must be accomplished prior to initializing the ACARS to preclude clearing the datalink requests (and any uplinks previously loaded). If the DB is swapped after ACARS initialization, an FMS RESET must be accomplished (see Volume 1, SP.5).

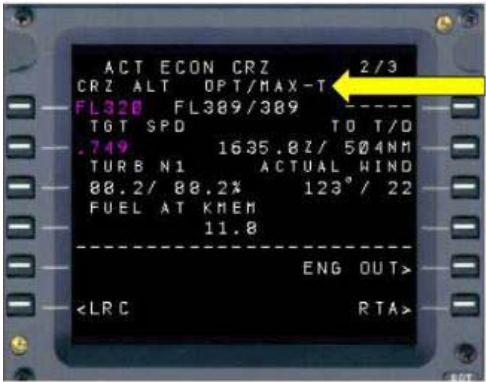
Maximum altitude limited by thrust (-T)

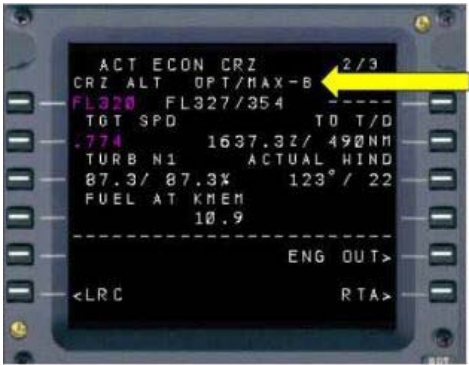
Maximum altitude limited by buffet (-B)
